*Short-Wave Transceiver Series*

# **XPA125B**

## **Maintenance Manual**

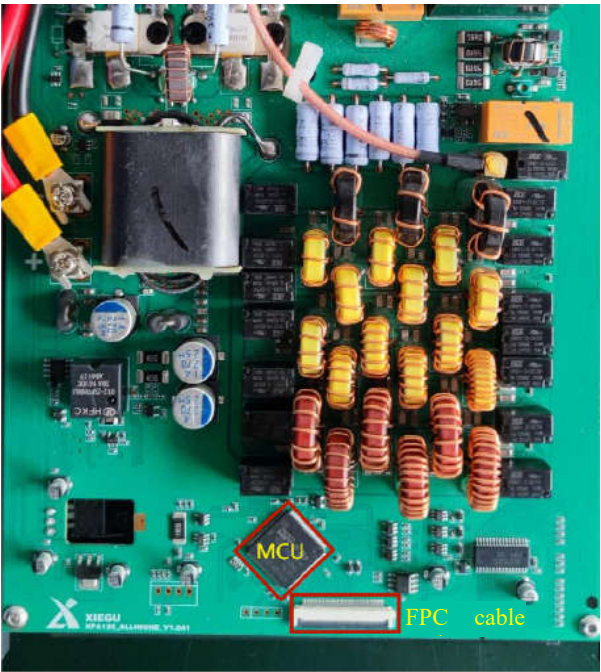
- Fault phenomenon: failure to save the state; the key is unresponsive

- This fault is mainly caused by cold solder joints on the component.

Fault phenomenon	Maintenance method	
	Mainboard	Check points
Failure to save the state; the key is unresponsive	Check the chip and FPC cable socket for cold solder	MCU & FPC cable socket

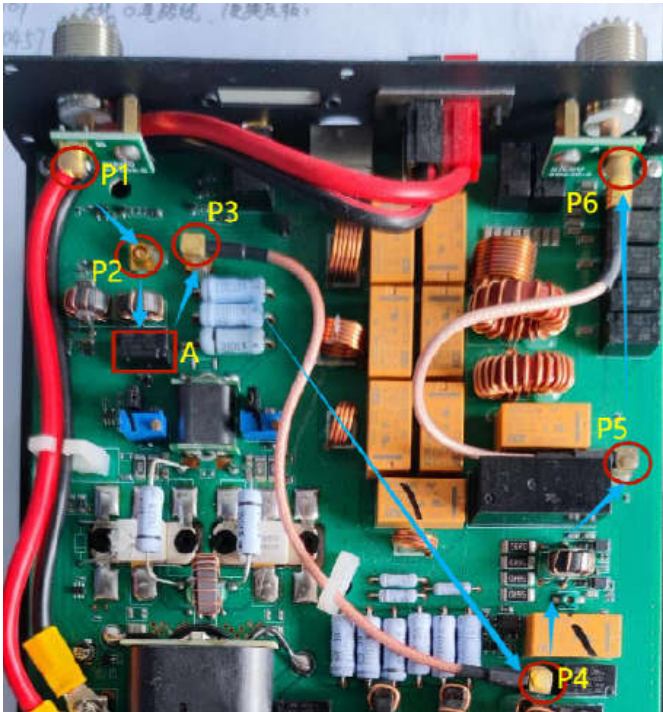
- Fault phenomenon: no through current

- There have been instances where the device has no through current due to missing solder in the pin of relay A.
- ◆ This fault is mainly caused by damaged signal line.

1. Unplug P2 and P5 signal terminals and check the antenna pedestal and signal line to see whether there is a short to-ground and a smooth path.
2. Check the path from P2 to P5.
  - In the shutdown mode, the signal routing is in a through-current state by default
  - Check whether the three signal lines are correctly inserted or in good condition (via the on/off position (gear) of a multimeter)
3. Check whether the core of the signal terminal is damaged or broken after insertion

Check points
Check whether the three signal lines are damaged
Check the antenna pedestal for short
Check the path between P2-P3 and between P4-P5
Check whether the terminal blocks are intact after insertion

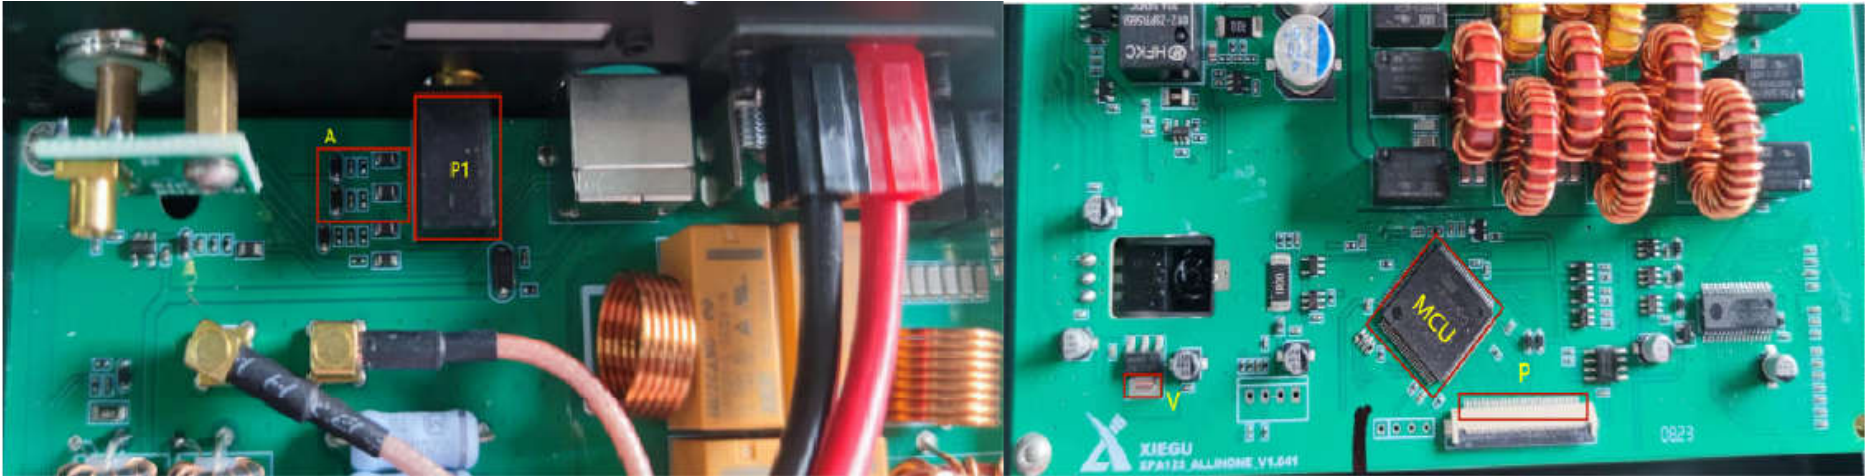
- Fault phenomenon: failure to write any program (Boot loader, firmware)

Fault phenomenon	Maintenance method	Check points
Failure to write Boot loader	Check whether the (main control power supply) point is 3.3 V	V
	Check whether the programmer (aka writer) is correctly connected	
	Check the chip pin for cold solder	MCU
Fault phenomenon	Maintenance method	Check points
Unable to write the firmware	Check the component for damage	A
	Check the pedestal for cold solder	P1
	Check the MCU for cold solder	MCU

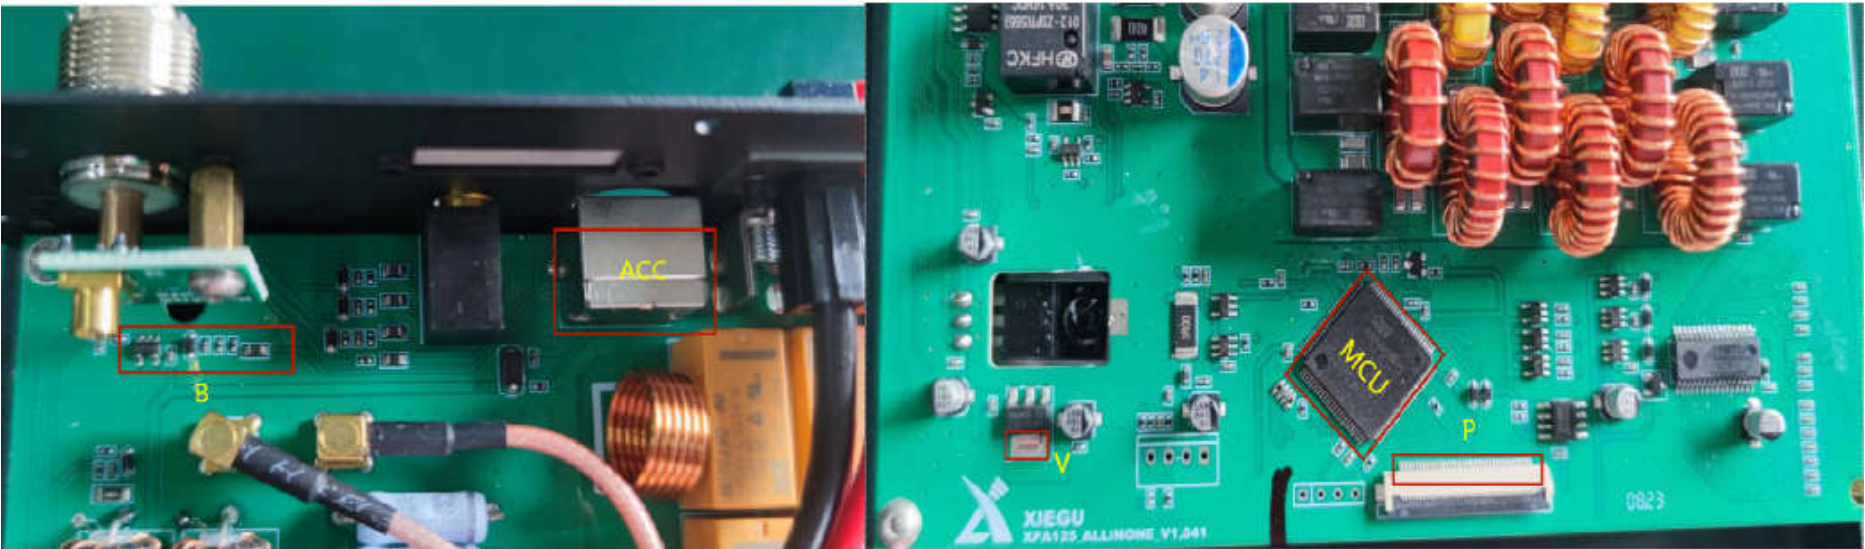
- Fault phenomenon: the automatic switching of the relay does not work (wave band voltage control failure)

- ◆ This fault occurs largely because the wave band voltage control line of ACC is broken due to the cold soldering of the component in area B.

1. Check to see whether there is wave band voltage.
2. Switching the frequency band will cause changes in the wave band voltage accordingly.
3. Check area B for cold solder joints on the component.
4. Check ACC welding.
5. Check whether there is a path between area B and MCU.
6. Check MCR for cold solder.

Check points
ACC seat
Area B
MCU

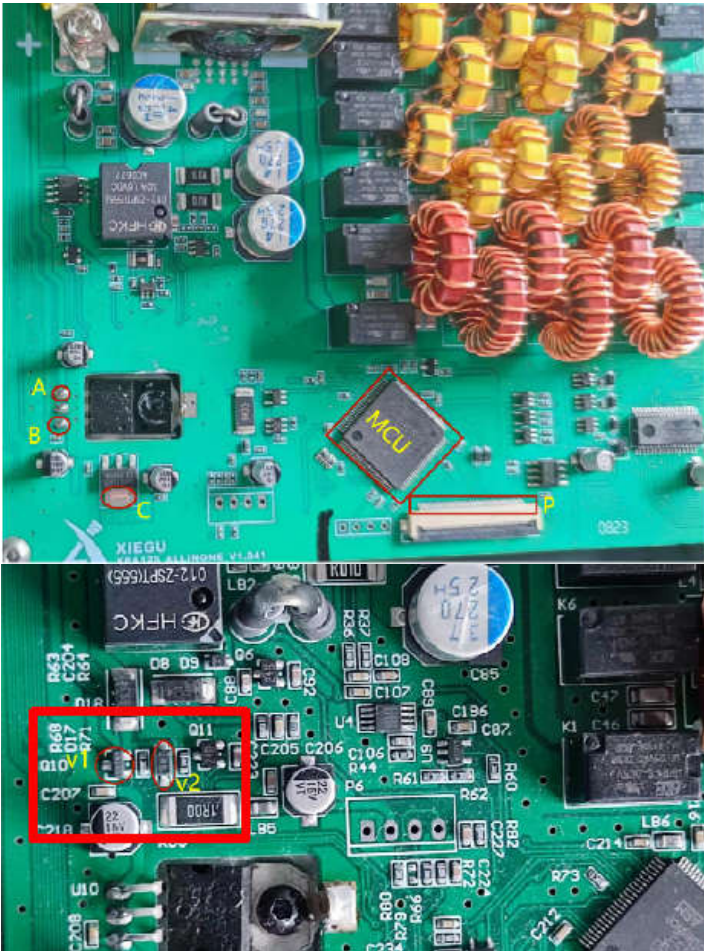
- Fault phenomenon: failure to start up

- Older version. Before the power supply module was updated: failure to start up.
  1. Check the red box in the left figure for component burnthrough (this is often the main reason for sending the device back for repair).
  2. Replacement of components V1 and V2:

1. Check whether all voltages are normal.
2. Check whether MCU has a program.
3. Check whether MCU and cable socket P for cold soldering.
4. Check whether the FFC cable connected to the head of the device is damaged.

Fault phenomenon	Check points	Voltage, V
Failure to start up	A	12
	B	5
	C	3.3

Component	Replacement
V1 (IRLML5203PBF)	Si2309
V2 (BZT52C5V1)	Change for new

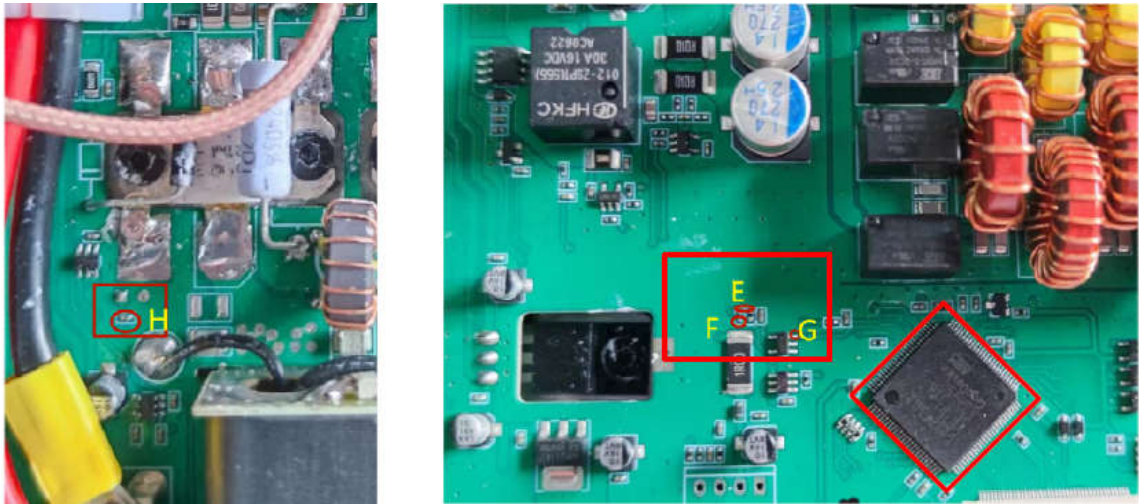
- Fault phenomenon: abnormal temperature display

Maintenance methods:  
■ As the thermistor is soldered by hand, point H is the focus of checking.

Fault phenomenon	Mainboard	Check points
Abnormal temperature display	Check the thermistor bypass capacitor for bridging (short)	H
	Check whether VCC voltage is 3.3 V	F
	Comparator input voltage (about 1.46 V)	E
	Comparator output voltage (about 1.46 V)	G
	Check the MCU for cold solder	Chip

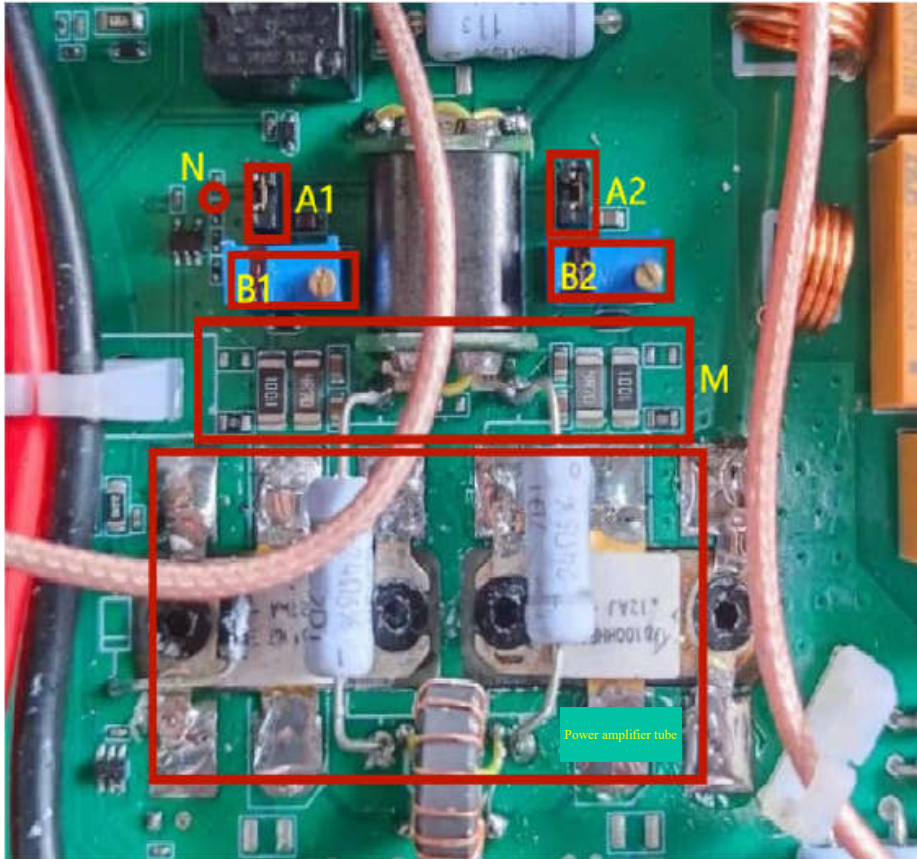
- Fault phenomenon: failure to tune the quiescent current

1. First, measure the power amplifier tube by use of a multimeter to see whether damaged or broken down.
2. Then, check whether A1 and A2 short-circuiting caps are installed in place.
3. Measure the voltage at point N, which should be around 5V (measure in the transmitting state).
4. Check B1 and B2 potentiometers for damage and cold solder.
5. Finally, check area M for component burnthrough or cold solder.

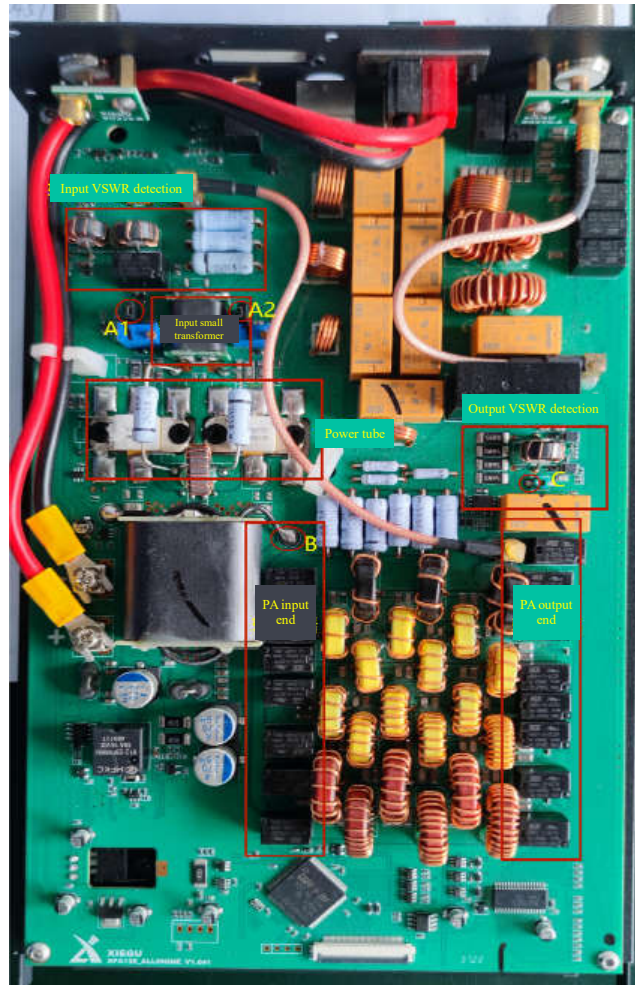
- Fault phenomenon: reactive power (high standing wave, low efficiency), high standing wave

◆ This fault is mainly caused by damages to the relay at Pa input and output ends as shown the left figure

- I. Prompt for high standing wave at input end
  1. Confirm whether the through-current state is normal (it might be caused by damages to the signal line at input end)
  2. Check the detected part of input standing wave (the fault of this part is mainly caused by coil breakage).
- II. Prompt for high standing wave at output end
  1. Confirm whether the through-current state is normal (it might be caused by damages to the signal line at output end)
  2. Check the detected part of input standing wave:
    - ① whether the coil is broken
    - ② whether there is any missing step in the standing wave modulation procedure

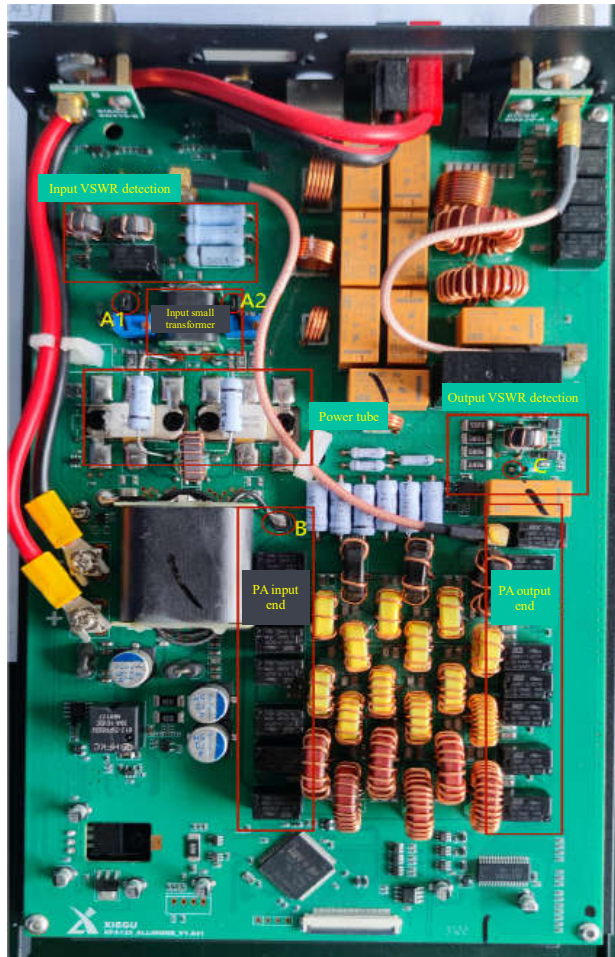
#### IV. All-band low efficiency and reactive power

1. First, confirm whether everything is normal in the through-current state.
  2. Next, confirm whether the power amplifier tube is damaged and whether the quiescent current is correct.
  3. Check whether PA switching replay is task switching (measure with an oscilloscope).
  4. Check the welding of the small transformer.
  5. Check the manufacturing process and welding of the large transformer.
- ◆ In most cases, it is caused by poor contact of the PA relay and cold soldering at the bottom of the small transformer.
  - ◆ The power amplifier has a high requirement for large transformer manufacturing process.

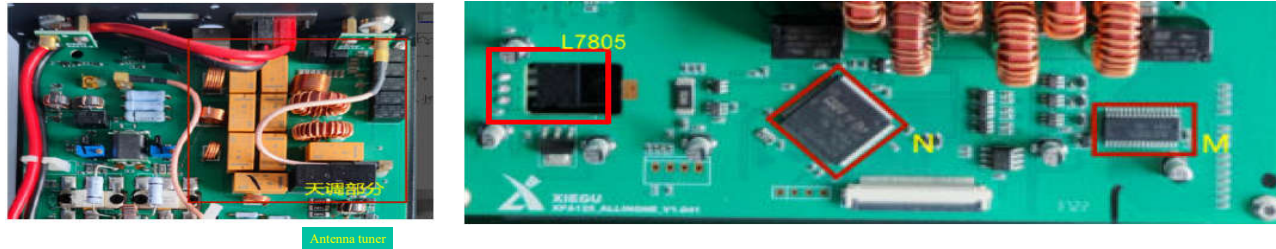
- Fault phenomenon: high standing wave of antenna tuner

1. First, confirm whether the power is normal if the antenna tuner is not in use (do not use the rooftop antenna);
  2. Check whether the relay and capacitor of the antenna tuner are burnt out;
  3. Check whether any component of the antenna tuner has cold solder joints (on the back side of PCB board, requiring another patch-welding)
  4. Check the welding of the control part (patch-welding for N and M).
- Fault phenomenon: the antenna tuner screen is blurred or does not light up
